Balloon Working Group Meeting

The NASA Ultra Long Duration Balloon Vehicle

Henry M. Cathey, Jr.
ULDB Balloon Vehicle Manager
NMSU/Physical Science Laboratory
Wallops Flight Facility

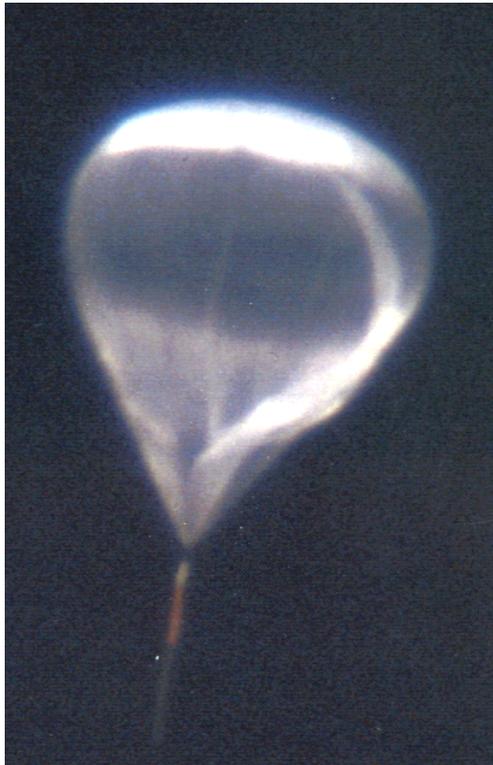
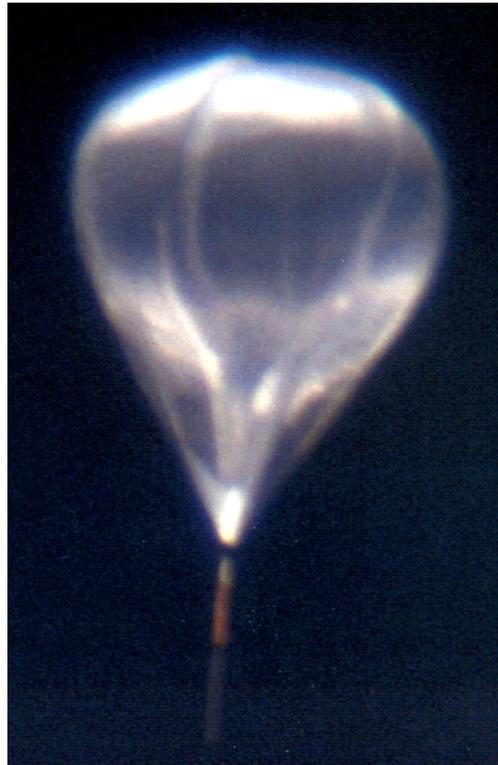
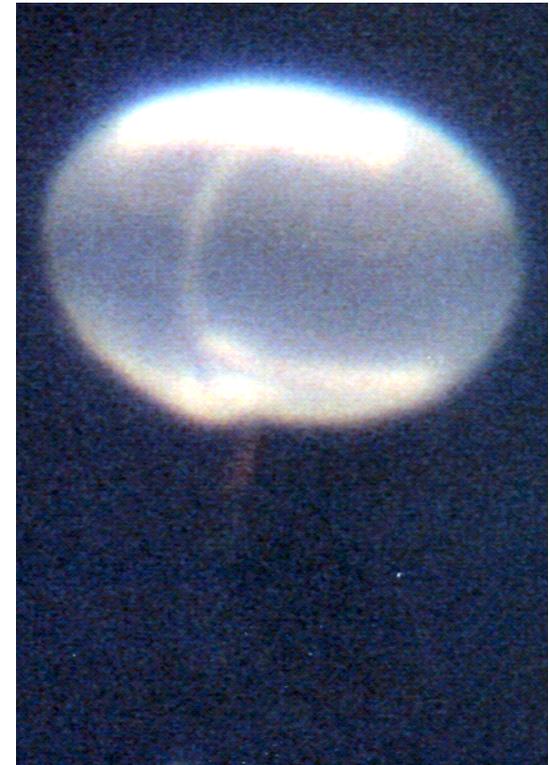
Phase IV Australia – Anomalous Shape

- Balloon pressurization and stable altitude occurred at 32.8 km (107,500 ft) (GPS altitude 33.8 km or 111,000 ft)
- Maximum daytime pressurization 120 Pa
- Observations and decision
 - Telescope observation showed shape discontinuity in the balloon
 - Flight continued through the day with minor variations in pressure observed
 - Altitude was very stable, holding at 32.8 km (107,500 ft) plus or minus 120 m (400 ft.)
- The decision was made to continue with the flight because performance was very close to that predicted and the pressure and altitude were very stable.

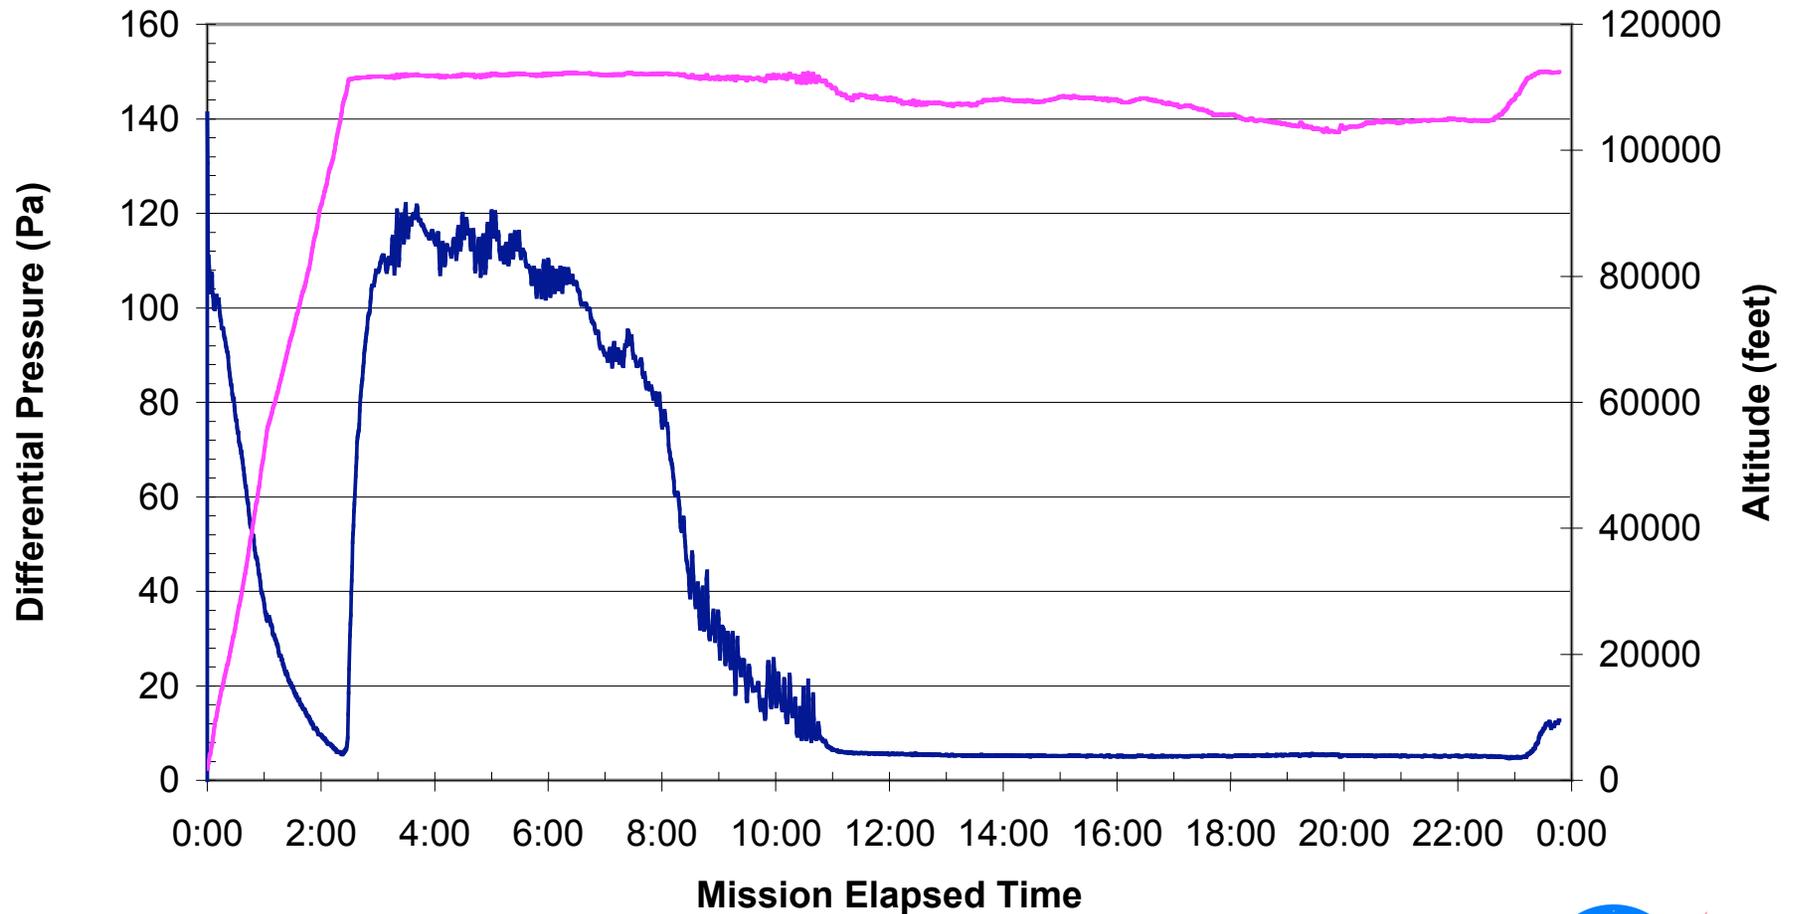
Flight 496- Flight Profile

- As the sun set, the pressure in the balloon fell off as expected
 - Balloon flew over thunderstorm
 - Ballast drops at night
 - To maintain altitude
 - Much greater quantity of ballast dropped than predicted
- After sunrise the MKS altitude returned to 32.6 km (107,000 ft)
- Differential pressure barely moved above the nighttime pressure
- As soon as the discovery of this was made, it was reported to operations personnel who executed flight termination
- Determined that the balloon developed a leak at some point during the flight

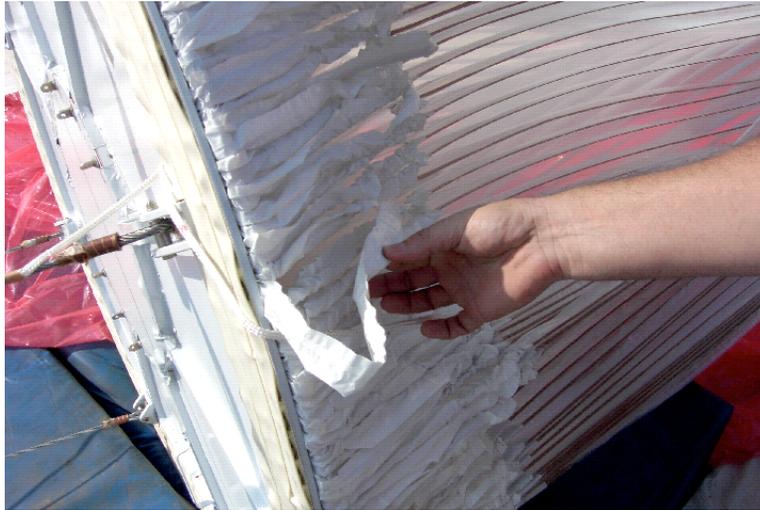
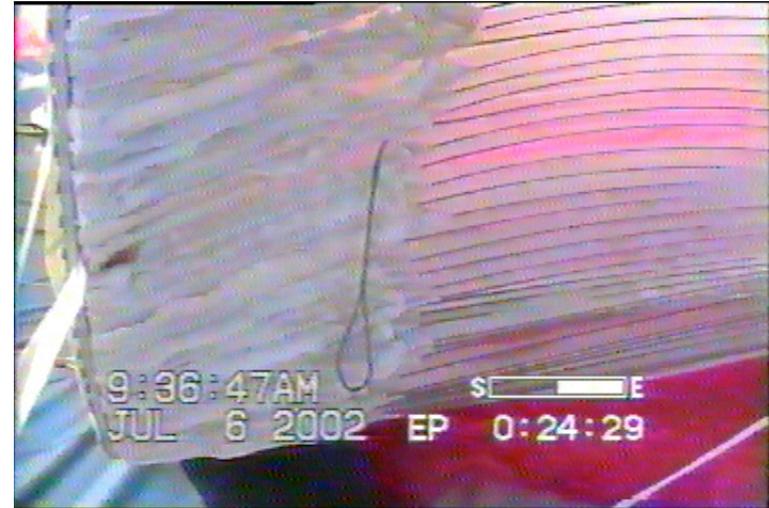
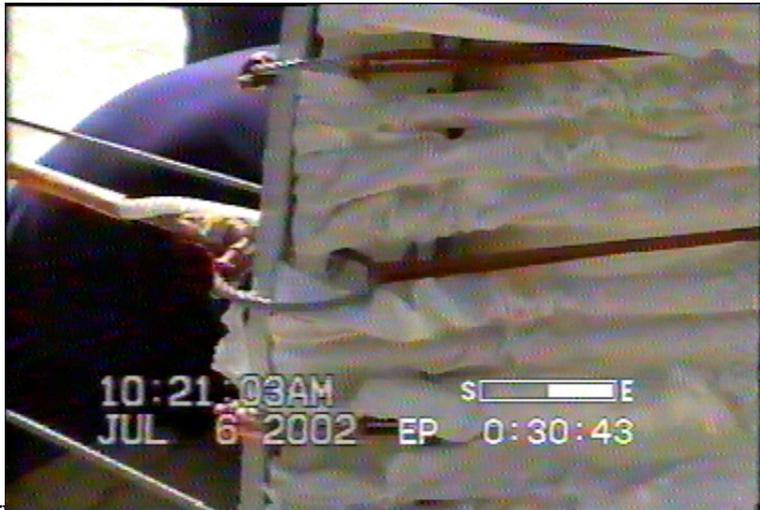
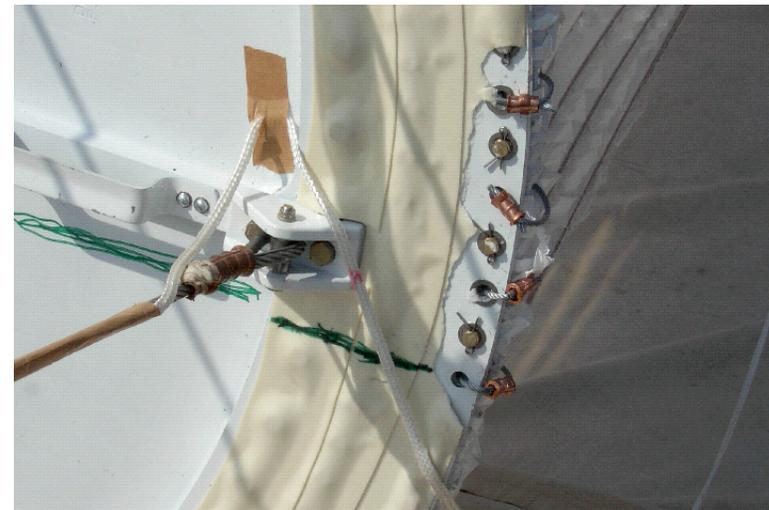
Flight 1580PT – Flight Line Issue

- Break down in manufacturing process
- Tendon attachment was a “blind” process
- Inspection of tendon attachment difficult - also a “blind” process
- Punctured tendons were inherent problem
- NSBF QA observed rather than inspected for this balloon
- Numerous recommendations made to BPO
- Full review and revision of production documentation completed – Material Specifications, Fabrication Procedures, and Quality Procedures
- Additional inspections with sign-off’s added

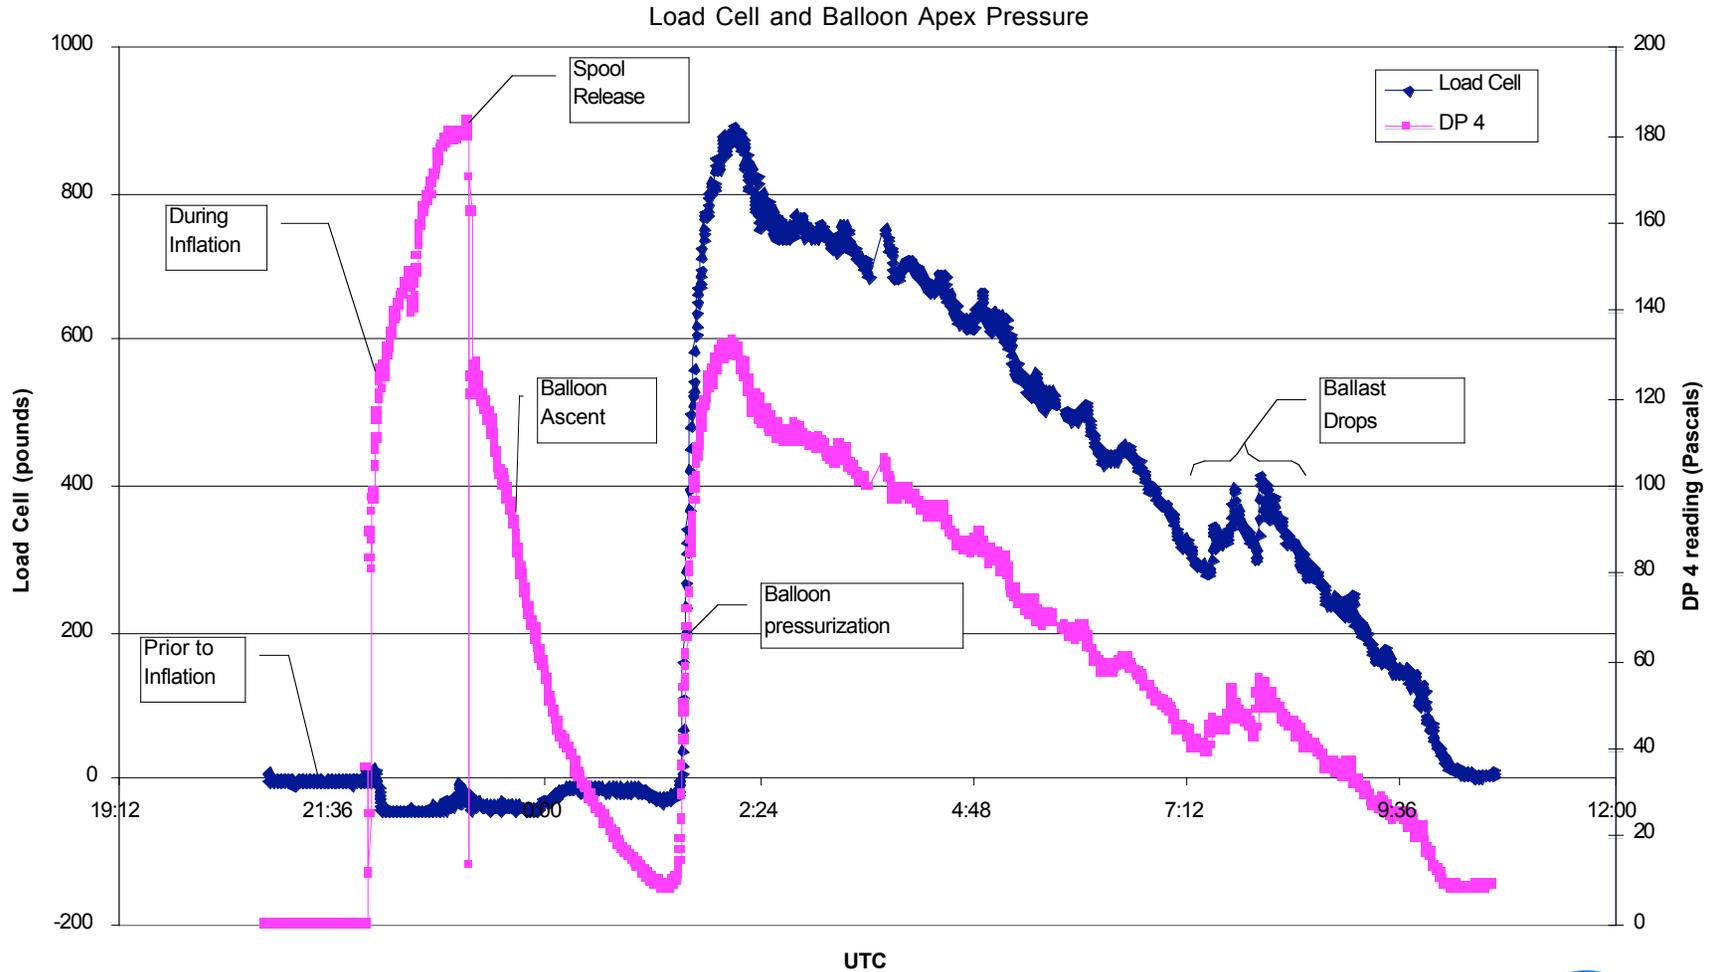
Flight Plot

- Ascent rates were within the expected ranges
- Smoothly transitioned into float.
- Auto-valve function activated to maintain balloon within pre-flight specified differential pressure limits – Auto-valve system worked as designed
- Balloon did not deploy properly (confirmed by up looking videos and telescope)
- Float altitude was a couple hundred feet below designed altitude
- After reviewing undeployed shape and performance data, decision made to terminate flight
- Flight terminated over a remote area on Aboriginal lands “near” a road

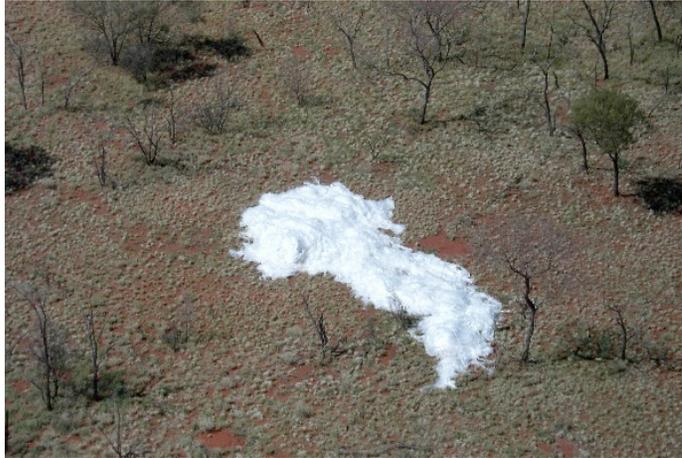
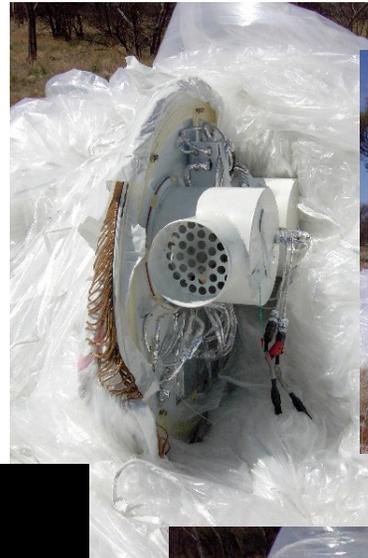
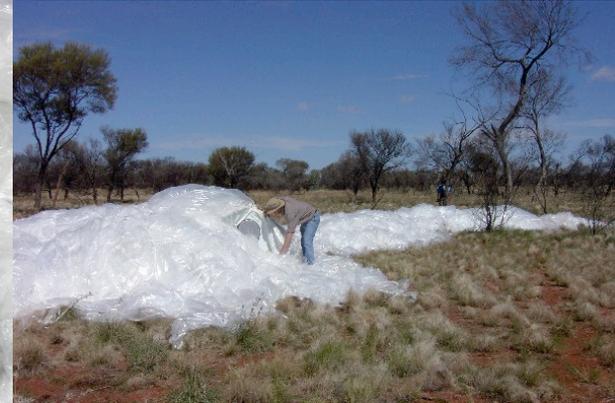
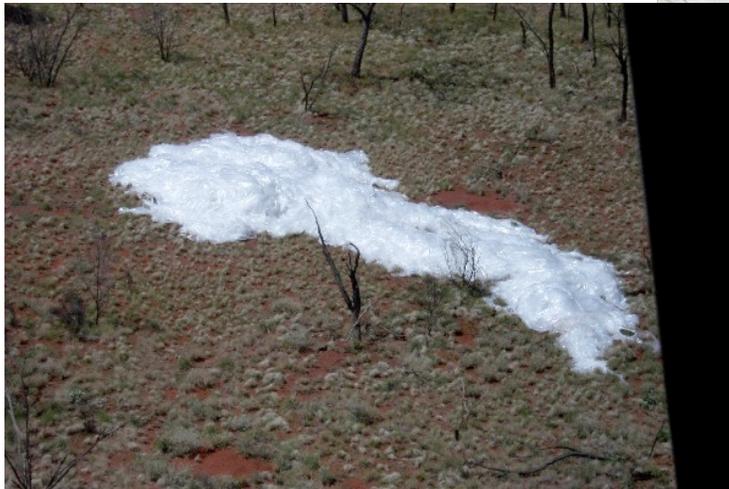
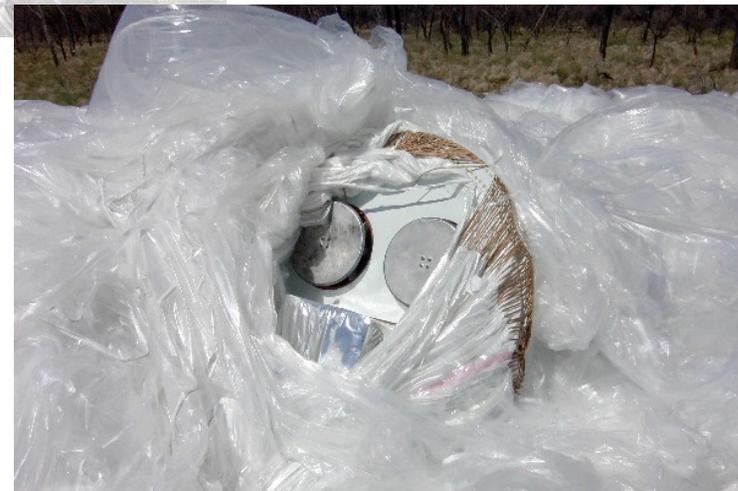
Recovery and Post Flight Photographs

- Payload found the only water for 100's of kilometers (“clay pan” Aboriginal Holiday spot)
- Balloon pile was a mess (like all balloons after flight) – damaged on descent
- Impact area measured (~33 ft by ~66 ft)
- Apex and base fittings looked as they did on launch
- All tendons were attached on apex and base
- Three small pieces of the balloon retrieved – final balloon recovery completed
- Balloon returned to the U.S. on June 20
